THE AERO-SPACE DIVISION SATURN BOOSTER BRANCH

$\bigwedge \emptyset$	
$\mathcal{C}_{\mathcal{V}}$	
$\sim 10^{0}$	
DOCUMENT NO	
DOCUMENT NO	
VOLUMEOF	
TITLE FLUOROSILICONE "O" RINGS IN GOX AT 500°F AND 1500 PSIG	•
MODEL NO. SAT V/S-IC CONTRACT NO. NAS8-5608	• . •
MODEL NO.	
ISSUE NO. M-13 ISSUED TO <u>National Aero</u> and Space a	rhix
	J ()
ISSUE NO. M-13 ISSUED TO Plational Wera	rautice
and Sauce a	dominica
	tio
	4.0
PREPARED BY	68
SUPERVISED BY El Clark 3/6	168
3-6	- 68
APPROVED BY W. W. Davis	
APPROVED BY	
APPROVED BY	
APPROVED BY

Fluorosilicone "0" rings in three sizes were **test**ed at 500 F and 1500 psig in pure oxygen/nitrogen for five (5) minutes with a vibrational input, simulating conditions as found in an **oxygen** flow valve on the S-IC. Results indicated the rings did not fail from oxidation, but from mechanical attrition; leakage rates were **used** to determine integrity of the seal.

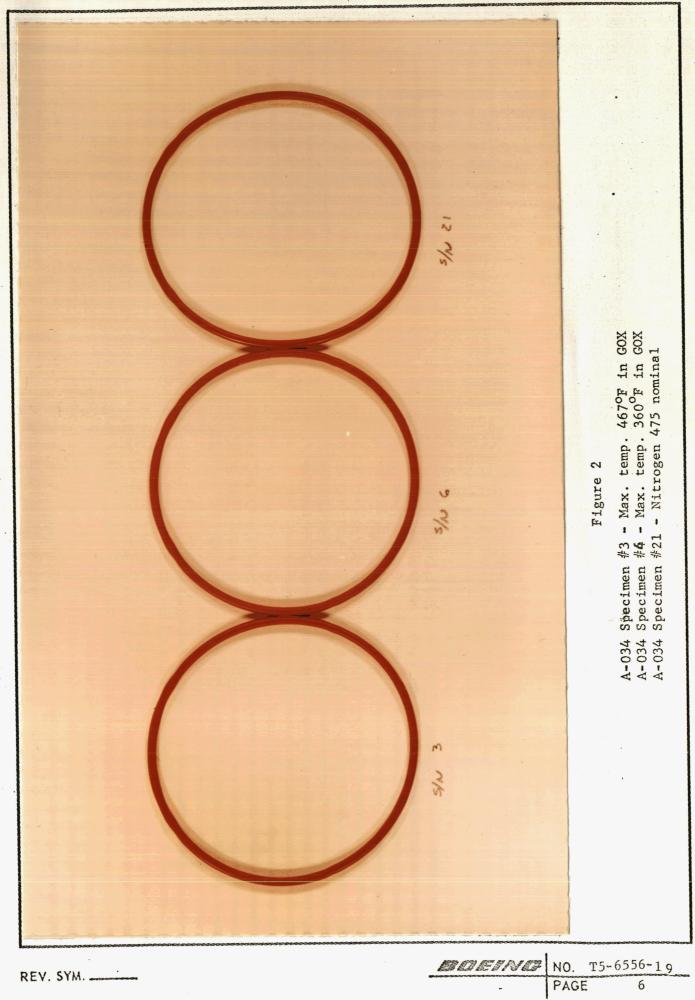
The A-034 ring, used as a static seal in the test fixture, showed no discernible mass or surface change, other than a slight extrusion due to the high pressure. The elasticity also was apparently unimpaired. Since this ring had the same exposure as the two smaller rings, with the exception of the rotational loading, it affirms the conclusion that the failure of the A-006 ring (Leakage) was caused by mechanical stress.

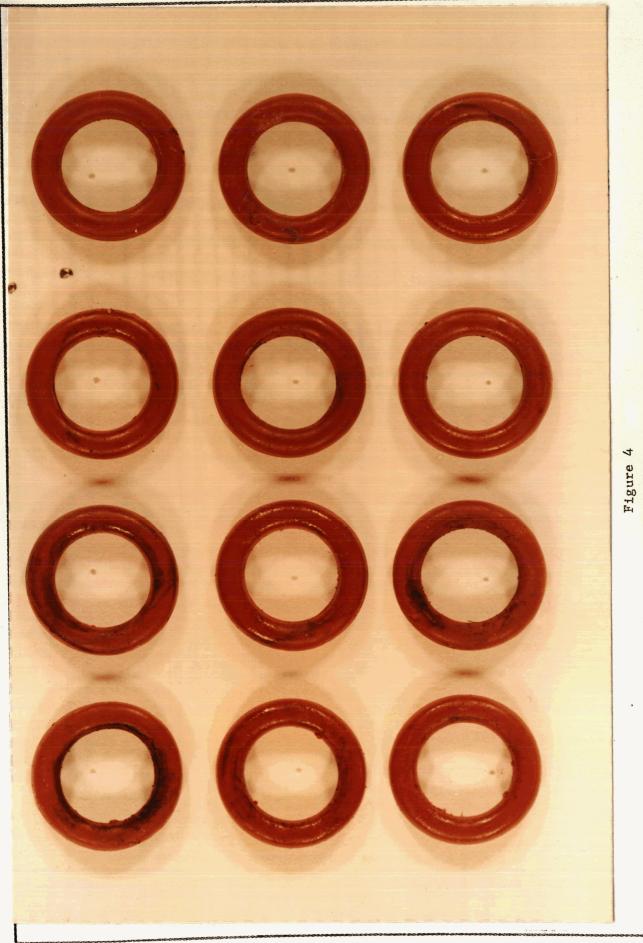
Twelve A-010 Rings Tested in GOX

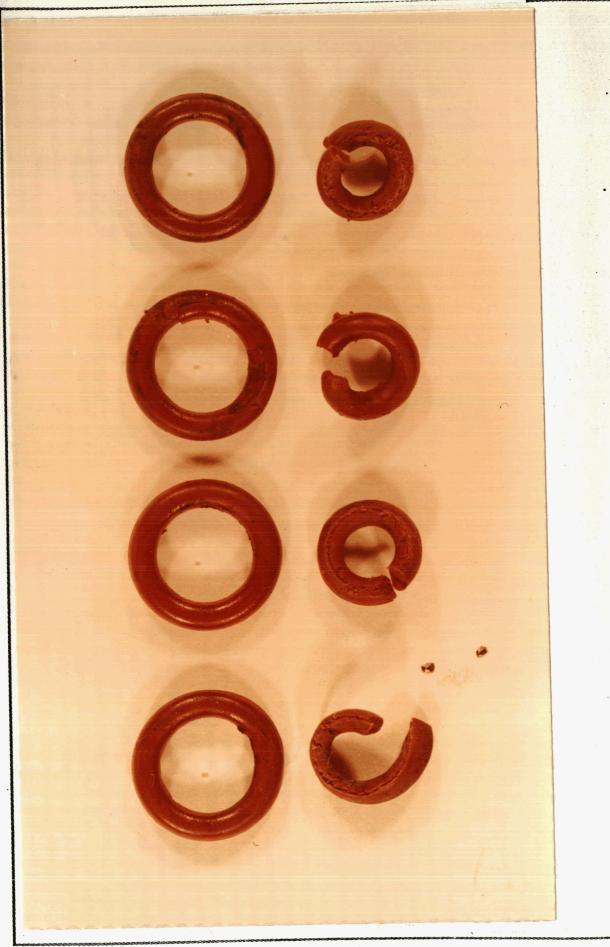
Figure 5

This conclusion is reinforced by inspection of those rings tested in nitrogen. Half of the A-006 rings so tested failed; the appearance of these rings was very similar to those failing after oxygen test; all of the failed rings showed abrasion.

Four A-010 and A-006 Rings in GN2

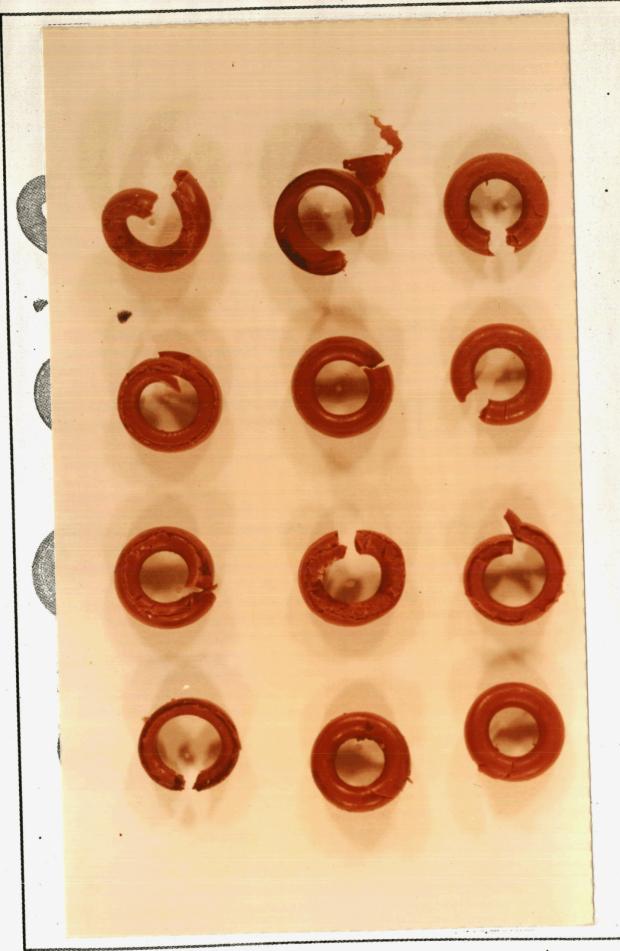
Regardless of atmosphere, the dynamic loading on the A-006 "O" ring (0.11 I. D.) together with temperature, caused a fretting of the ring surface, and this, coupled with the loss of small particles which had been torn from the surface, was sufficient to cause leakage failure. The two other sizes, A-010 and A-034, 0.24 and 2.1 I.D. respectively did not fail.

Figure 7
Twelve A-006 Rings tested in GOX
